### Board briefing – DAM SAFETY QUARTERLY REPORT

#### Quarterly Featured Damsite – Aberfeldie Dam

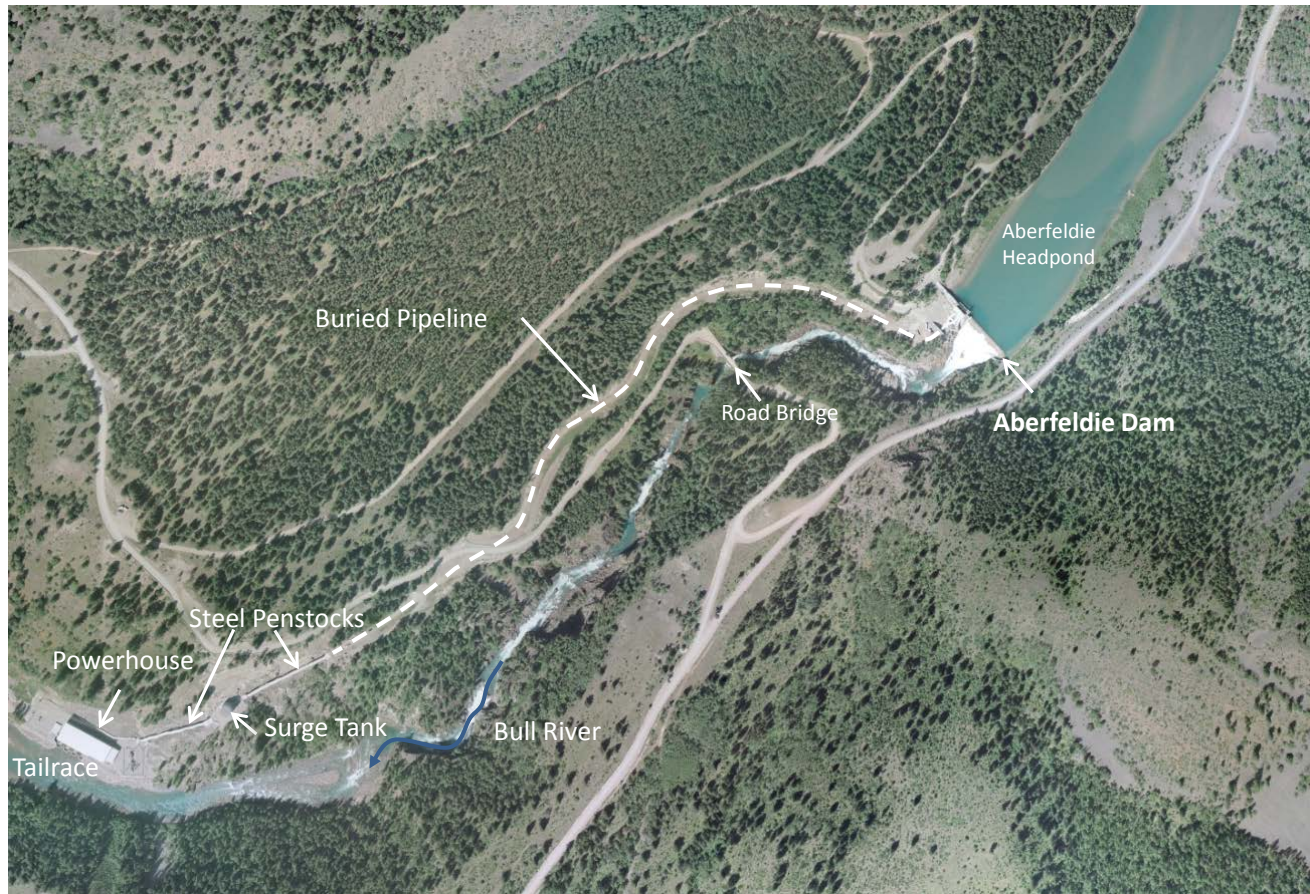
*Aberfeldie Dam*

The Aberfeldie Dam is a concrete gravity dam founded on bedrock. The dam is 32 metres high and approximately 135 metres long with the power intake located near the right abutment, a log sluice and a 60 metre wide free overflow spillway. Flashboards were originally installed along the spillway crest to raise the elevation of the headpond after the freshet but these have not been used in decades.

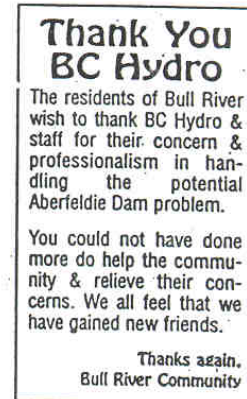
KOOTENAY ADVERTISER  
JULY 5/99

The Bull River carries a high sediment load which is deposited against the concrete dam. In 1999, the stability of the dam was assessed using the most recent surveyed sediment level and it was determined that the dam did not meet stability criteria during flood loading. As the 1999 freshet was expected to be higher than usual, 24/7 surveillance was established at the dam and a manned warning system was installed in the Community of Bull River for the duration of the freshet.

**Aberfeldie Dam during the 1999 freshet**

In late 1999, the dam was anchored with 29 fully grouted post-tensioned cable strand anchors to increase the stability of the dam under seismic and flood loading.

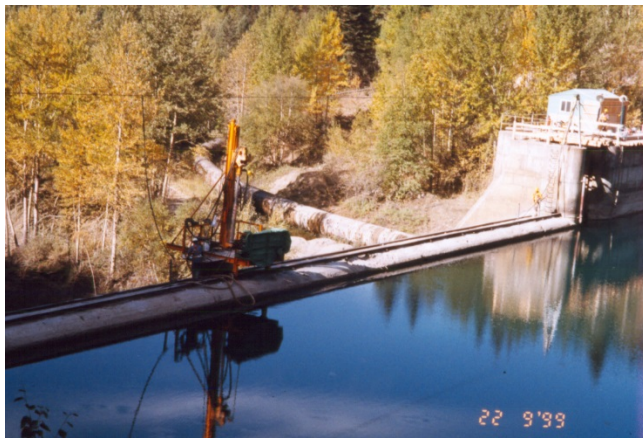
**Drilling holes for the post-tensioned anchors**

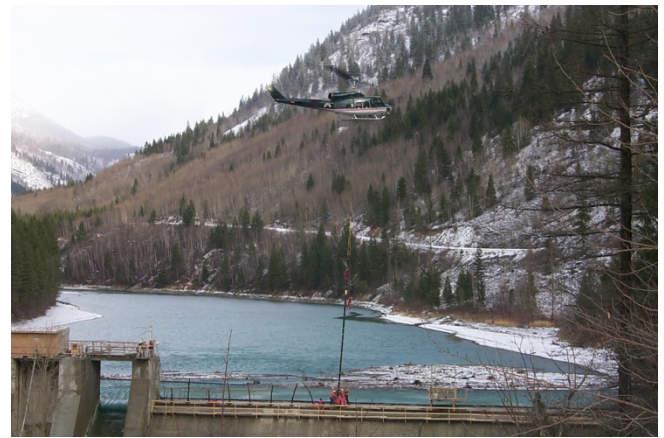
**Installation of a post-tensioned anchor in the spillway**

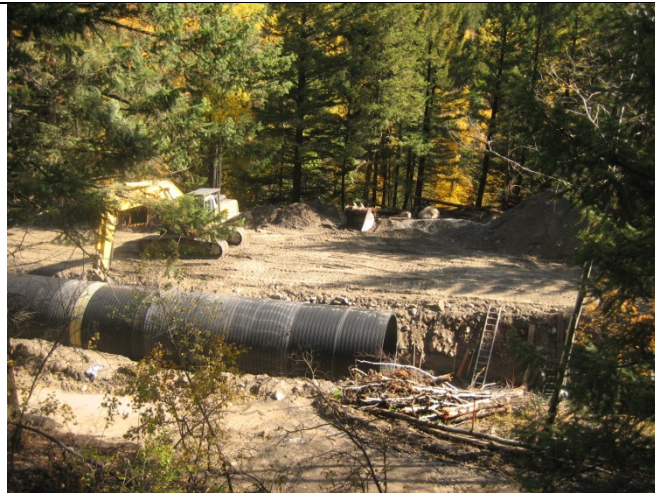
Construction of the new penstock

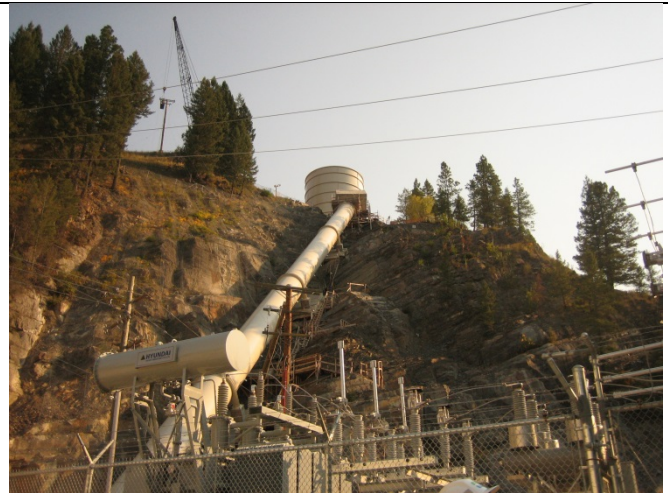
New steel penstock and surge tower

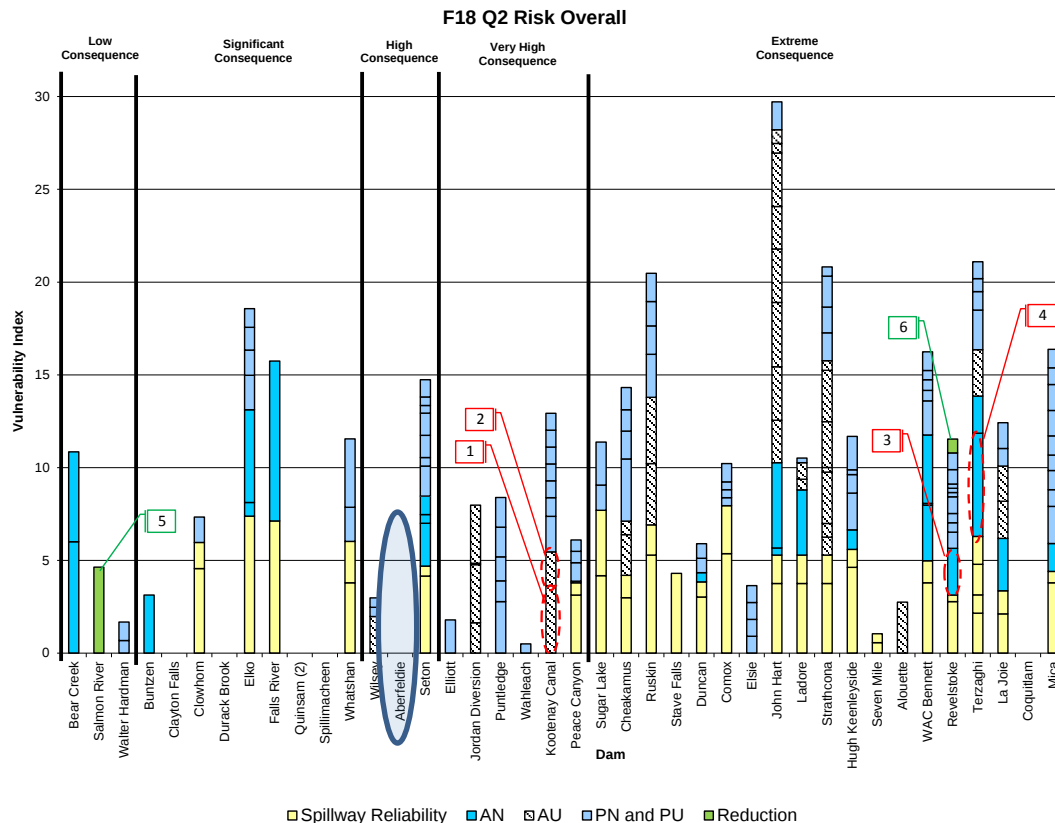
**Figure 1 - Dam Safety: Overall Risk Profile**

- Kootenay Canal Dam** – Updated analyses indicate the headworks centre pier is not stable for the design earthquake.
- Kootenay Canal Dam** – Updated analyses indicate the South gravity blocks are not stable for the design earthquake.
- Revelstoke Dam** – Movement of the Marble Shear Block has caused cracking of the spillwaychute concrete.
- Terzaghi Dam** – The design of the Terzaghi spillway does not meet modern design practices and could be susceptible to failure under normal load spills.
- Salmon River Diversion Dam** – The dam was decommissioned in Q2.
- Revelstoke Dam** – An error was corrected in a calculation of the vulnerability index for failure of the 731A Nose.
