### Board briefing – DAM SAFETY QUARTERLY REPORT

The purpose of this report is to update the Capital Projects Committee of the Board of Directors on key dam risk management activities during the period from October 1, 2018 to December 31, 2018, and to provide reasonable assurance that the safety of dams operated by BC Hydro continues to be managed to the established guidelines and criteria of the Dam Safety Program.

The Comox Dam is being featured in this quarterly report. A two page summary of the dam has been prepared containing key data, photos and short descriptions of the dam and current issues. Similar summaries for all BC Hydro dams are in preparation. These summaries will be available via links in future quarterly reports and this “Featured Dam Site” section will be discontinued.

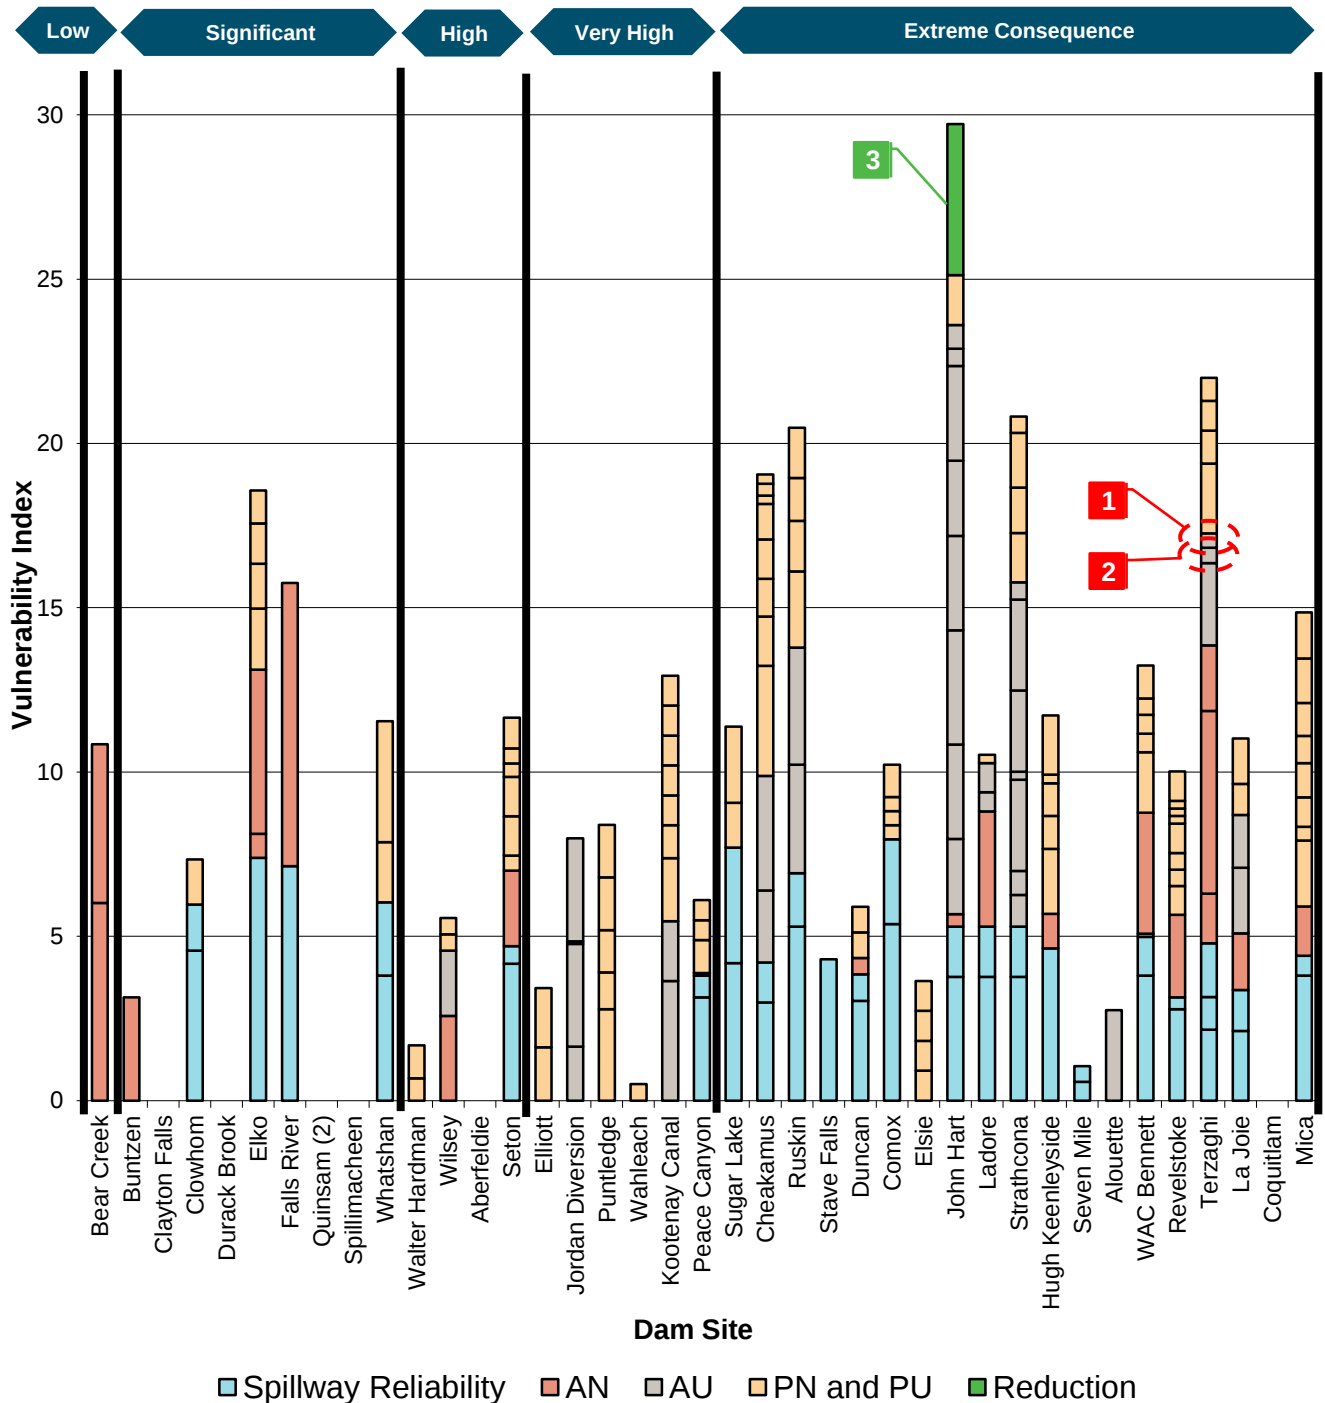
Notable changes in Vulnerability Index in F2019 Q3 are described below and identified on Figure 1.

- 1**    A Vulnerability Index **addition** of 0.47 (AU deficiency) at Terzaghi Dam due to capacity to pass only approximately 80% of the updated Probable Maximum Flood, but with an estimated probability of overtopping the dam of less than  $1.7 \times 10^{-6}$ .
- 2**    A Vulnerability Index **addition** of 0.43 (AU deficiency) at Terzaghi Dam due to the possibility of the spillway chute walls being overtopped when passing extreme floods. The spillway was originally designed to have a capacity of about 1,275 cubic metres per second but the current Probable Maximum Flood requires discharge through the spillway greater than this.
- 3**    A Vulnerability Index **reduction** of 4.6 at John Hart Dam due to the permanent dewatering of the wood stave penstocks, eliminating the risk related to the penstocks failing under seismic loading.

**Figure 1** Dam Safety overall risk profile at the end of F2019 Q3, as represented by the Vulnerability Index. Notable changes are identified.

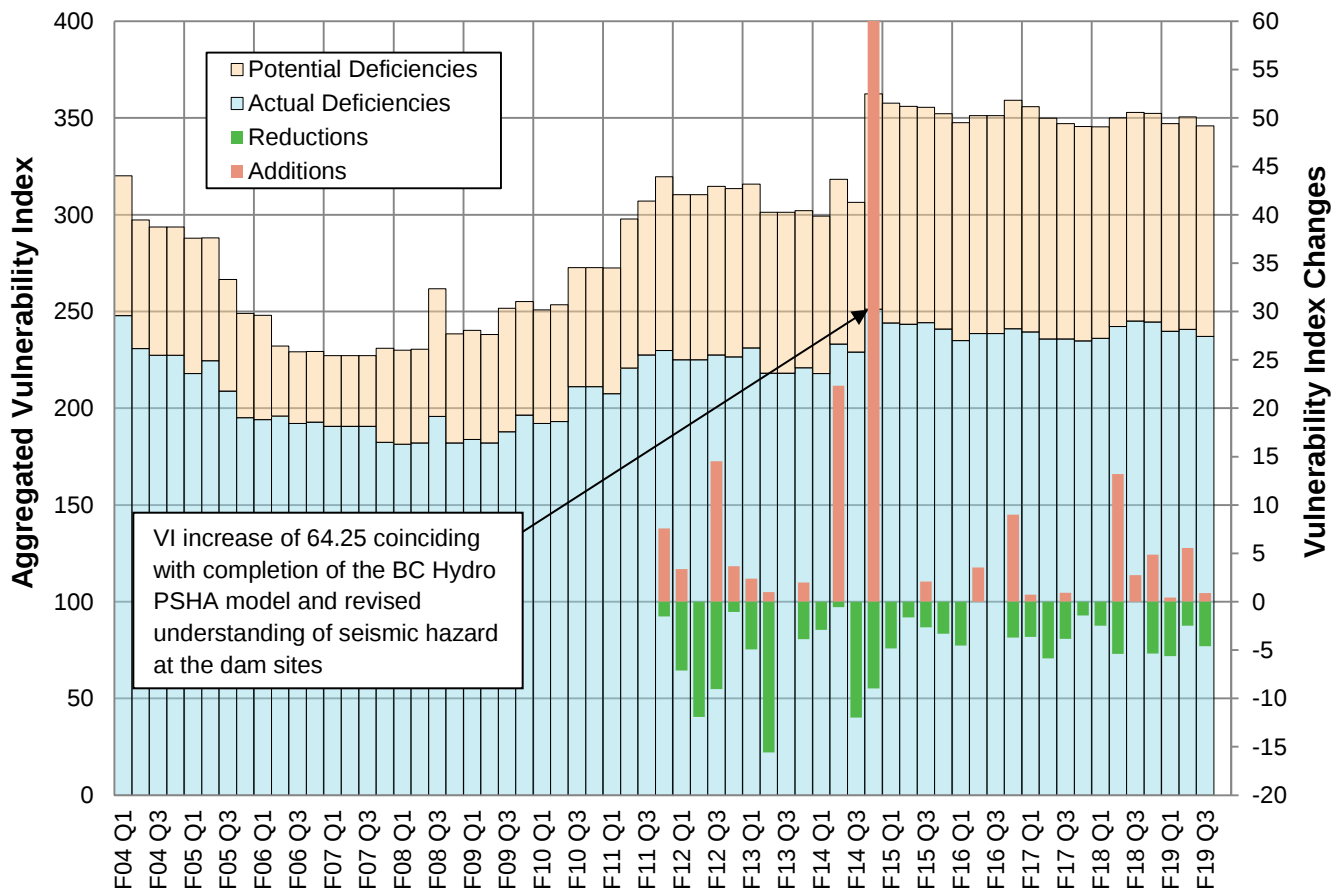
Changes in Vulnerability Index for actual and potential deficiencies, aggregated across the entire fleet of dams, are tracked on a quarterly basis and shown in Figure 2. This is an indication of the changes in the understanding of BC Hydro's dam safety risk profile. Additions are due to the development or recognition of new issues. Reductions are due to risk remediation projects delivered through the Capital Plan, completed repairs and corrective maintenance, and resolution of issues via Dam Safety Investigations. Existing issues are re-examined on a regular basis and re-rated as required. These changes—additions and reductions—have been tracked since the end of Fiscal Year F2011.

**Figure 2** Changes and trends in the Vulnerability Index aggregated across the BC Hydro system. Note: the bars are “stacked” such that total aggregated VI is given by the top of the Potential Deficiencies bar.

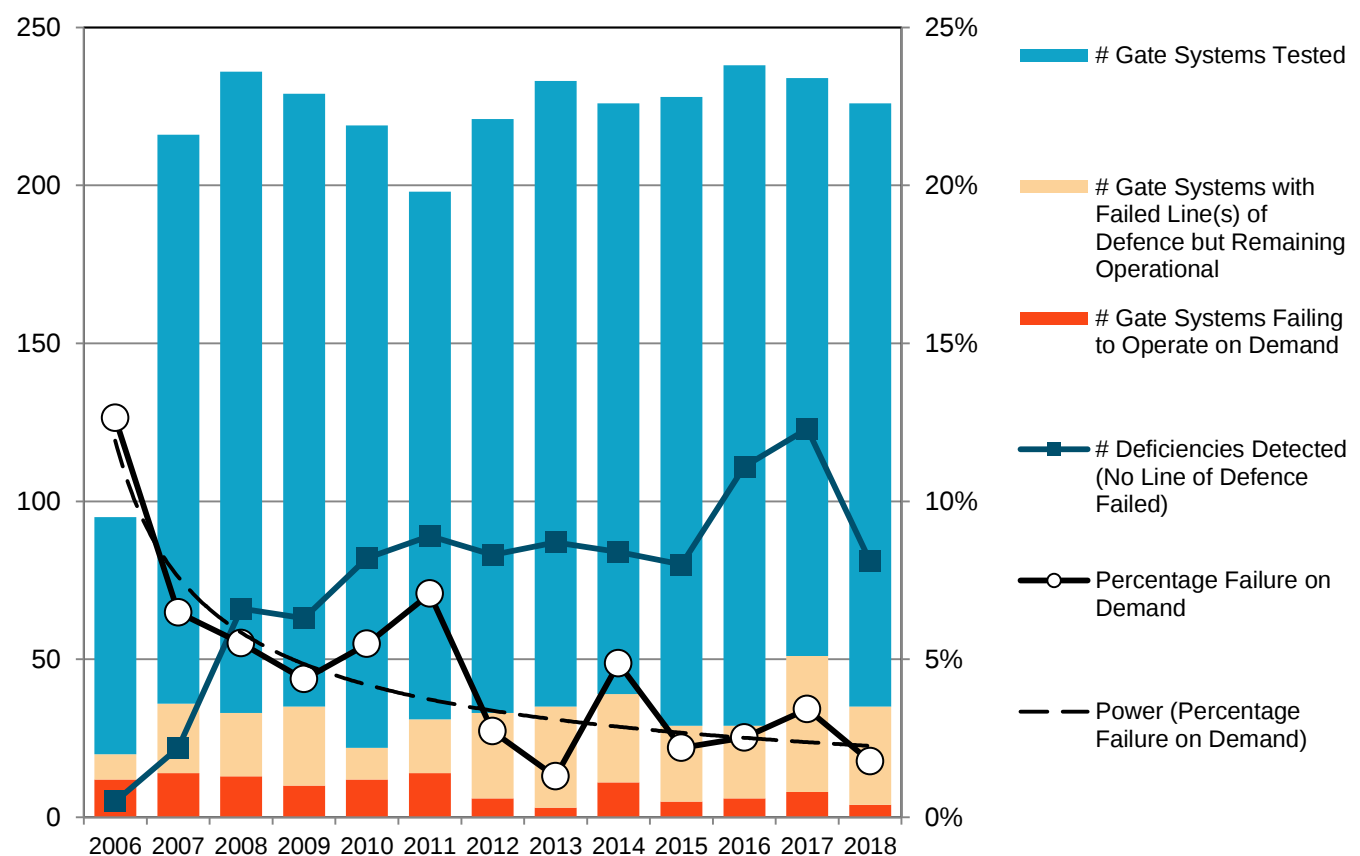
In F2019 Q3, 56 scheduled gate tests at 23 sites were carried out. Two gate systems failed to operate on demand during testing. In five other cases, while gates did operate on demand, certain individual components of the gate system malfunctioned or were found to be in unacceptable condition.

**Figure 3** Deficiencies detected and rates of failure to operate on demand during flood discharge gate testing.

Figure 3 additionally shows that the number of deficiencies identified each year through testing is not diminishing. It is not yet clear that the detection of deficiencies has settled into a reasonably steady state that would be commensurate with a well-established maintenance program. Dam Safety is presently evaluating maintenance records and developing metrics to assess the status and adequacy of maintenance of flood discharge gate systems. These metrics will be included in and become a regular part of future reports.
