### Executive summary

The purpose of this report is to update the Operations, Planning, Information & Technology Committee of the Board of Directors on key dam risk management activities during the period from July 1 to September 30, 2022 and to provide reasonable assurance that the safety of dams operated by BC Hydro continues to be managed to the established guidelines and criteria of the Dam Safety Program. To keep the Committee as fully abreast of the Dam Safety Program as possible, some notable developments that took place after September 30, 2022 but before the completion of this report have also been included.

## 10: Dam Safety Quarterly Report

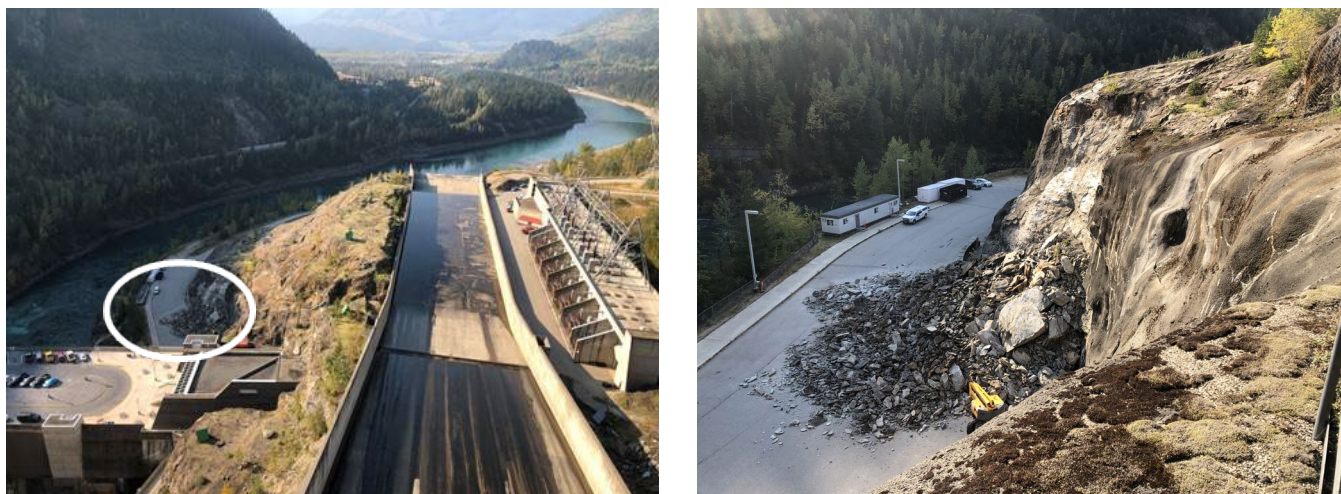
A rockfall occurred into the main parking lot at Revelstoke Generating Station at approximately 2:00 am on the morning of October 5, 2022. Comprising approximately 350 cubic metres of rock, the rockfall occurred on a feature known as the Marble Shear Block, over which the dam’s spillway is routed and below which is the principal access road to the generating station. Nobody was in the vicinity at the time and there were no injuries. The rockfall and potential instability of adjacent surfaces poses no threat to the dam, spillway or other critical infrastructure at the site, as instrumentation within the Marble Shear Block conclusively shows that there has been no global movement or instability of the Block. The access road to the generating station is partially blocked, however, and the road is closed. Access via the Visitor’s Centre and parking on the powerhouse roof remains open. See Figure 3, below, for photos showing the location and extent of the rockfall.

**Figure 3** Rockfall on the Marble Shear Block at Revelstoke Dam and Generating Station. At left: the location of the rockfall as viewed from above the spillway. At right: view of the rockfall onto the access road and main parking lot of the generating station.

Dam Safety has established monitoring of the slope above the road through daily point cloud laser surveys, drone surveys, and inspections of the slopes above for signs of potential progressive failure. Engineering is presently completing designs for a temporary protective berm, composed of lock blocks and rock, to be constructed along the road centerline, that would contain a similar rockfall and allow one lane of the access road to be opened up for safe delivery of essential equipment and materials to the station. Construction will be sequenced such that construction crews will always be working behind the constructed protective works and not be directly exposed to the rockfall hazard. This work is being

funded under the Dam Safety Investigations budget while an emergent project is being initiated to design and implement permanent stabilization of the rock slope.

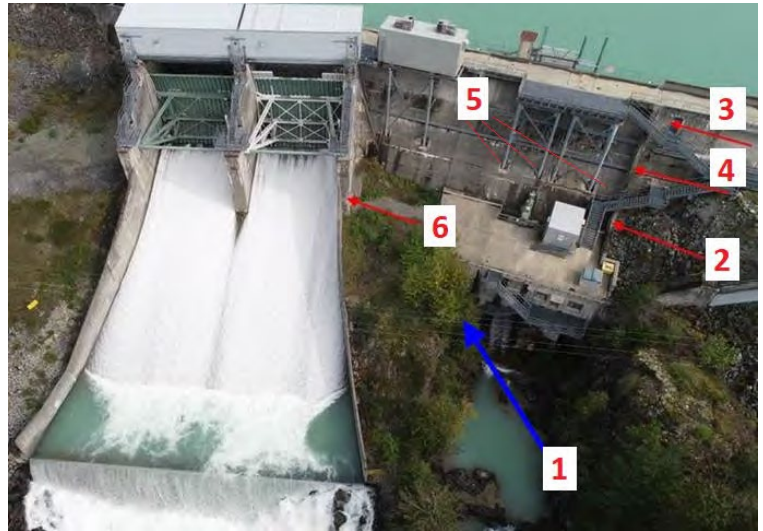
One maintenance project of interest took place at Cheakamus Dam. Various areas of the concrete dam are deteriorating due to alkali aggregate reactivity, as shown in Figure 4 at right. Repairs were made at two of the locations – areas 2 and 6 – and included trial applications of two products that are intended to mitigate the ongoing chemical reaction that is leading to the deterioration. These areas will be monitored for effectiveness of the treatment.

**Figure 4** Drone photo showing areas of Cheakamus Dam where concrete is deteriorating due to alkali aggregate reactivity.

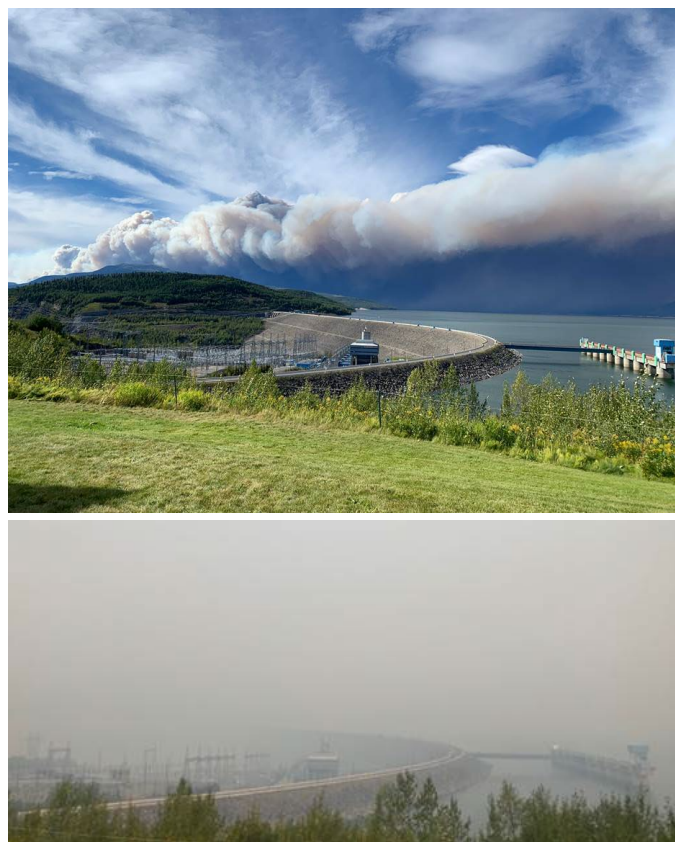
The wildfire did not pose a material hazard to the safety of either dam, but dam safety activities and considerations did impact BC Hydro’s response and contingency planning. Principally, WAC Bennett Dam’s spillway had been taken out of service for much-needed upgrades to the concrete surfaces within the WAC Bennett Dam – Spillway Concrete Upgrades Project. (See “Capital Projects” later in this report.) With large sections of the spillway’s concrete surface removed for this work, returning the spillway to service would have required eight days per the Interim Dam Safety Risk Management Plan. Williston Reservoir, however, was well below the Storage Reservation Curve elevation in place for management of flood risks at Site C and even further below the Maximum Normal Reservoir Elevation, so there were no tangible risks relating to overtopping of the dam and no dam safety priorities for returning the spillway to service. With the spillway out of

**Figure 6** Smoke from the Battleship Mountain fire, as seen from WAC Bennett Dam: on September 8, 2022 (top) and September 9, 2022 (bottom).

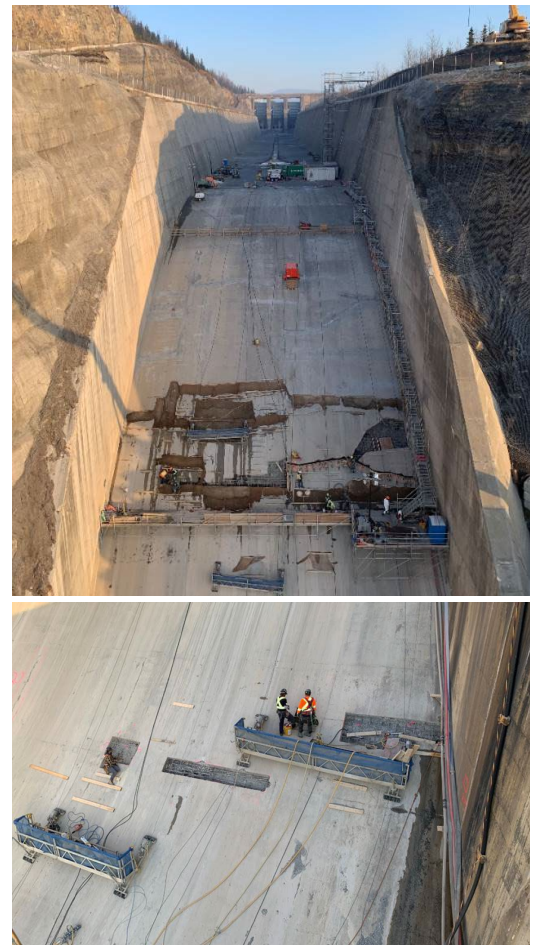
This project follows the Spillway Chute Upgrade Project, completed in 2016, which identified damage throughout the entire length of the spillway chute and remediated the highest priority areas located immediately upstream of the flip bucket. The specific sections of the spillway chute to be upgraded as part of this project are the next highest priority sections in the inclined chute, both above and below the previously resurfaced area, which have deteriorated more quickly than had been forecast.

**Figure 7** Concrete removal and replacement work in the WAC Bennett spillway.

The objective of this project is to upgrade the condition of the concrete spillway chute of WAC Bennett Dam to ensure its continued safe operation.

The concrete placement was completed at the end of October. Hoarding and curing of the concrete is expected to extend into mid-November.

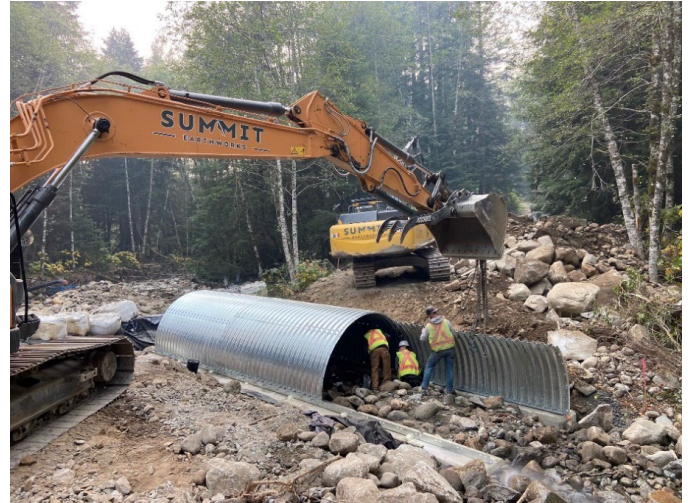
Access to Wahleach Dam and to the generating station's power intake on Jones Lake is by way of a steep and narrow, 8-kilometre-long logging road. That road is vulnerable to washouts during heavy rains, preventing access to the dam. The atmospheric river events in November 2021 washed out a section of the road and caused flows in the spillway discharge channel to jump the bank and form a confluence with Wahleach Creek upstream of where the spillway discharge channel merges with Wahleach Creek. Temporary road access was restored promptly following the atmospheric rivers.

**Figure 8** Installation of a new culvert under the Wahleach Dam access road to prevent future washout.

Subsequently, an emergency project was initiated to install a culvert across the road and to restore the bank of the spillway discharge channel to prevent recurrence. That work was completed on October 25, 2022.
