### Executive summary

The purpose of this report is to update the Operations, Planning, Information & Technology Committee of the Board of Directors on key dam risk management activities during the period from July 1 to September 30, 2022 and to provide reasonable assurance that the safety of dams operated by BC Hydro continues to be managed to the established guidelines and criteria of the Dam Safety Program. To keep the Committee as fully abreast of the Dam Safety Program as possible, some notable developments that took place after September 30, 2022 but before the completion of this report have also been included.

## 10: Dam Safety Quarterly Report

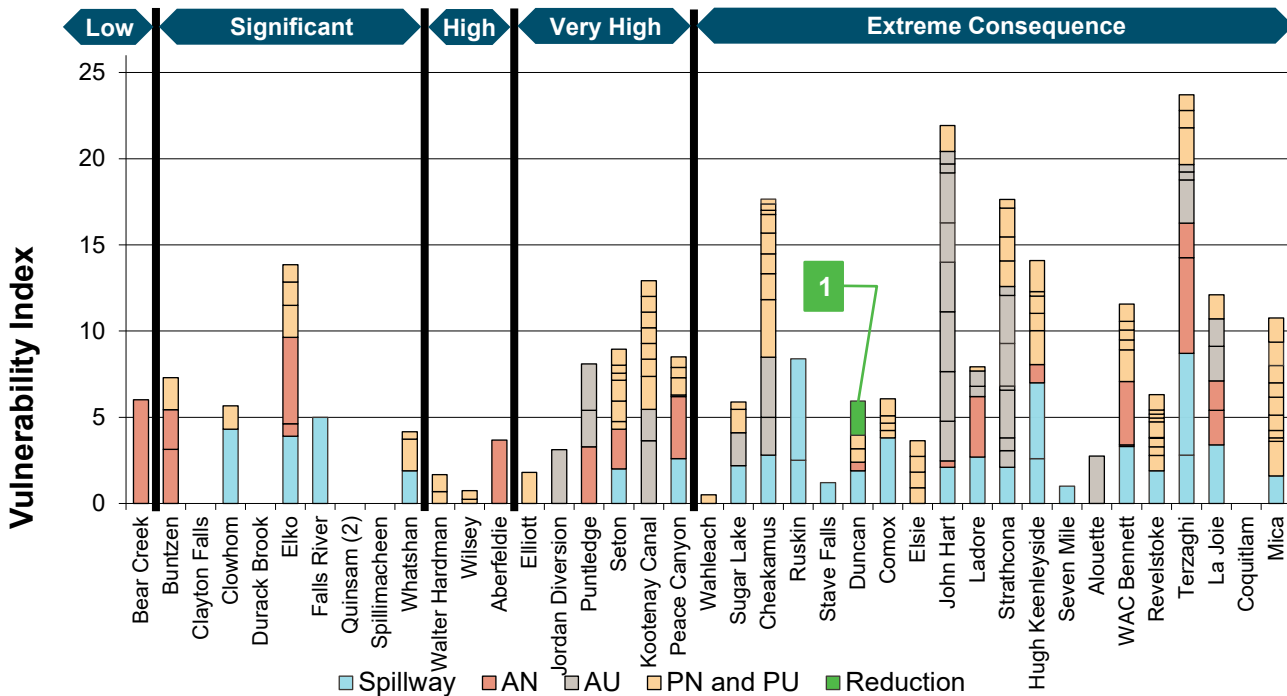
There was one notable change in Vulnerability Index in F2023 Q2, as described below and identified in Figure 1.

**Figure 1** Dam Safety overall risk profile at the end of F2023 Q2, as represented by the Vulnerability Index. Changes this quarter are indicated by the numbered boxes.

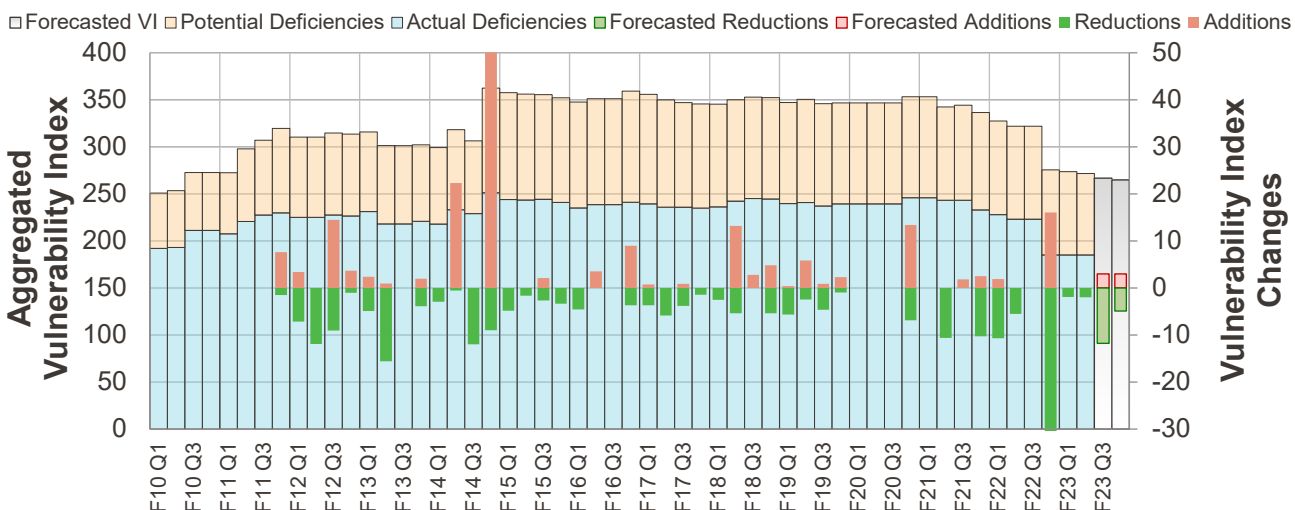
Identified physical deficiencies in BC Hydro’s dams and the degree of concern that exists with respect to their impact on the integrity and performance of the dam are characterized by the Vulnerability Index. The higher the value of the Vulnerability Index (scale of 0-10), the higher the likelihood of that deficiency leading to poor performance. The Vulnerability Index for each identified issue at each dam site is shown in Figure 1. Vulnerability Indices for the individual deficiencies are aggregated into stacked bars for each dam, and dams are sequenced from left to right in order of increasing downstream consequences per the BC Dam Safety Regulation. Changes in Vulnerability Index for actual and potential deficiencies (including those related to spillway reliability), aggregated across the entire fleet of dams, are tracked on a quarterly basis and shown in Figure 2.

**Figure 2** Historical and forecast changes and trends in the Vulnerability Index aggregated across the BC Hydro system.

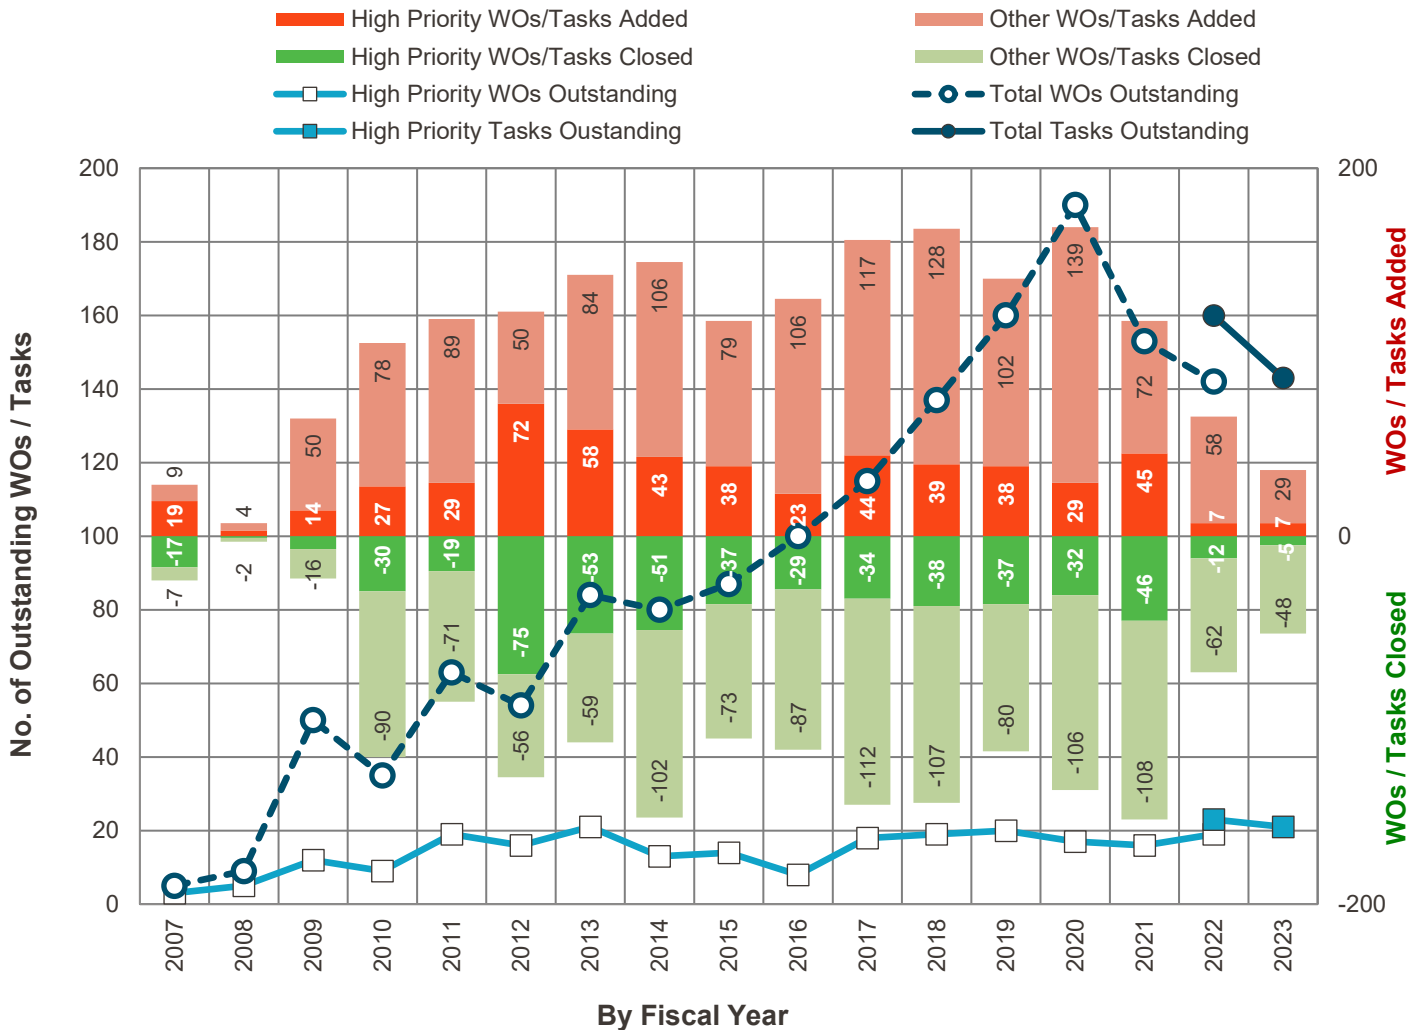
The number of outstanding gate maintenance tasks is shown in the chart in Figure 5, below. As explained above, the total number of outstanding maintenance tasks has remained nearly steady in F2023 Q2, dropping from 144 to 143. Through the first two quarters of F2023, there has been a net decrease in outstanding maintenance tasks from 160 to 143.

**Figure 5** Number of outstanding corrective and condition-based spillway gate maintenance work orders and tasks, new work orders and tasks added, and work orders and tasks closed as at the end of each previous fiscal year.
